A REVIEW OF METALLURGICAL FACTORS IN DEVELOPMENT OF THE VARHEAD MK 19 MOD O FOR ASM-N-7A BULLPUP GUIDED MISSILE

A Review of Metallurgical Factors in Development of the Warhead Mk 19 Mod O for ASM-N-7a BULLPUP Guided Missile

NWL REPORT NO. 1728

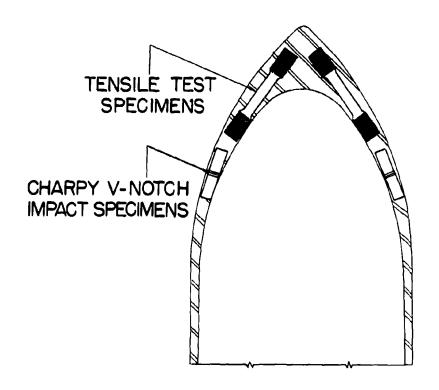
FIGURE 4

LOCATION OF TENSILE AND CHARPY IMPACT SPECIMENS

- c. A macroscopic examination or macro-etch test was made of a longitudinal cross section.
- d. Tensile tests were conducted on two specimens taken from the ogive section in a near longitudinal direction as shown in Figure 4.

- e. Charpy impact tests were made on V-notch specimens taken from the ogive section in a near longitudinal direction as shown in Figure 4. The notch of the specimen was approximately perpendicular to the outside surface of the body. At least two specimens were tested at 0°C and in some cases specimens were tested at various other temperatures to determine the transition temperature from ductile to brittle failure. Here the percent of granular fracture was determined from the fracture appearance of the impact specimen and plotted vs testing temperature. A curve was drawn and the temperature for a point on the

- Charpy Impact Properties The Charpy impact test results in Table 1(C) made at 0°C on specimens from the location shown in Figure 4 show that all warhead bodies with the exception of AISI 4140 warhead body No. la exceed the impact strength minimum of 40 ft-lbs specified in Table $l(\Lambda)$. The AISI 4140 warhead body No. la with the lowest impact strength had the highest yield and tensile strength and AISI 4340 warhead body No. 3 with the highest impact strength had the lowest yield and tensile strength. Table 1(C) shows the AISI 4340 bodies to be superior to the AISI 4140 bodies in impact strength determined with specimens taken either in the near longitudinal direction as shown in Figure 4 or in a transverse direction from the heavy ogive section. This superiority is more pronounced on comparing the transition temperatures in Table 1(C). Here the AISI 4340 bodies gave much lower transition temperatures than the AISI 4140 bodies. These results demonstrate that the AISI 4340 bodies are somewhat tougher than AISI 4140 bodies.

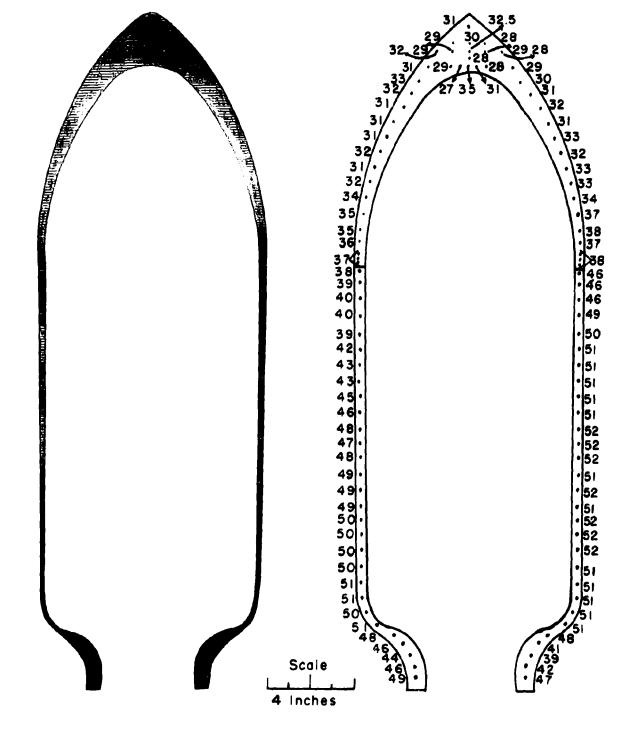
FIGURE 6

SAMPLE WARHEAD NO. 1
HARDNESS DISTRIBUTION AND MACROSECTION OF BULLPUP WARHEAD
EX 29 MOD 1 AISI 4140

Hardness Values: Rockwell C Scale Etch: 50% Hydrochloric Acid

- f. <u>Hardness</u> The results of Rockwell C hardness tests of warhead bodies are given in the hardness distributions in Figures 6 through 12. A grouping of hardness values according to warhead number, nose section, and wall section is tabulated as follows:

Warhead body No. 1 represents the first lot of warheads received at a time when the contractor's heat treating practice was under development. The wide variation in hardness of body No. 1, shown above and in Figure 6, indicated that heat treatment was not optimum and necessitated reheat treatment of this lot of EX 29 Mod 1 bodies. For this reason the hardness test results of body No. 1 are not used in any subsequent hardness comparisons. Warhead body No. la represents the reheat treated warheads. In general the hardness of the warhead bodies is higher in the wall section than in the nose section as expected from the shape of the body. The overall hardness of the AISI 4340 bodies No. 2, 5 and 6 is within the aim 35 to 40 Rockwell C range listed in Table 1(A) with the exception of one value of 34 in the nose section of body No. 5. The AISI 4140 bodies No. la and 4 show a wider variation in hardness than the AISI 4340 bodies No. 2. 3. 5 and 6. particularly in the heavy nose section.

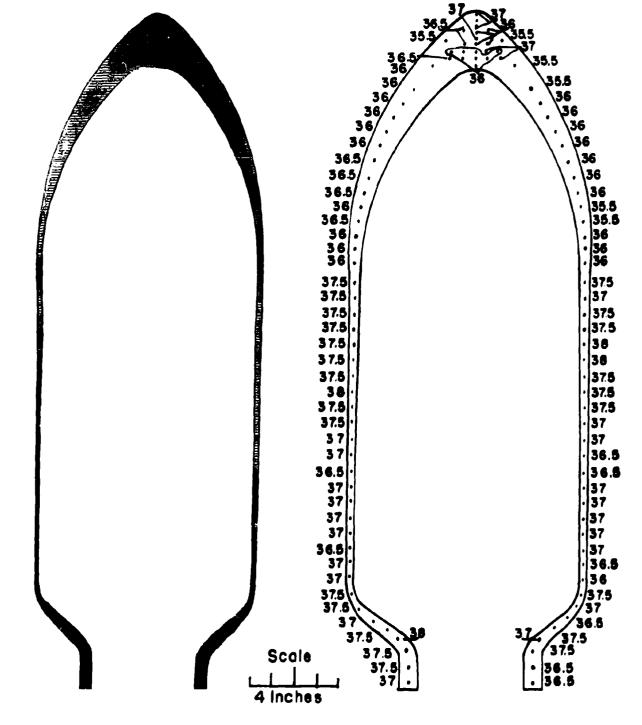
PHD-55239 FIGURE 7 January 1959

SAMPLE WARHEAD NO. 2
HARDNESS DISTRIBUTION AND MACROSECTION OF BULLPUP WARHEAD
EX 29 MOD 0 AISI 4340

Hardness Values: Rockwell C Scale Etch: 50% Hydrochloric Acid

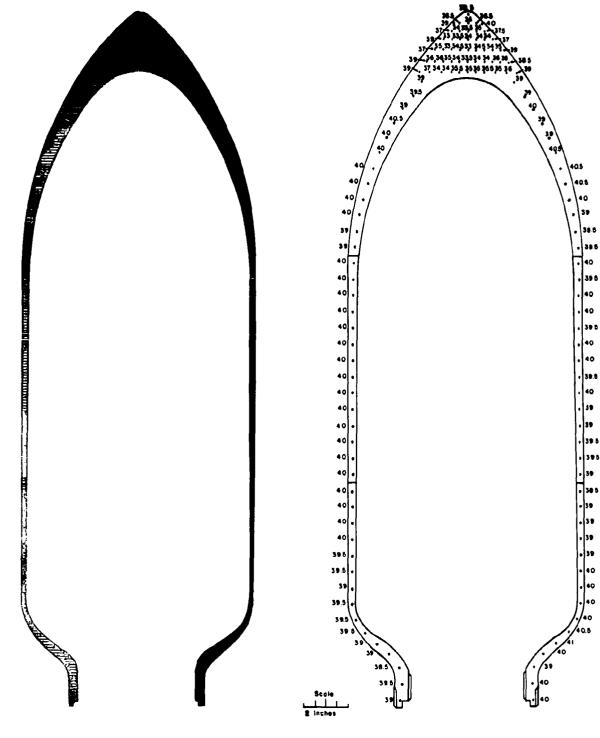
PHD-55298 FIGURE 8 February 1959

SAMPLE WARHEAD NO. la HARDNESS DISTRIBUTION AND HACROSECTION OF BULLPUP WARHEAD EX 29 MOD 1 AISI 4140 REHEAT-TREATED Hardness Values: Rockwell C Scale Etch: 50% Hydrochloric Acid

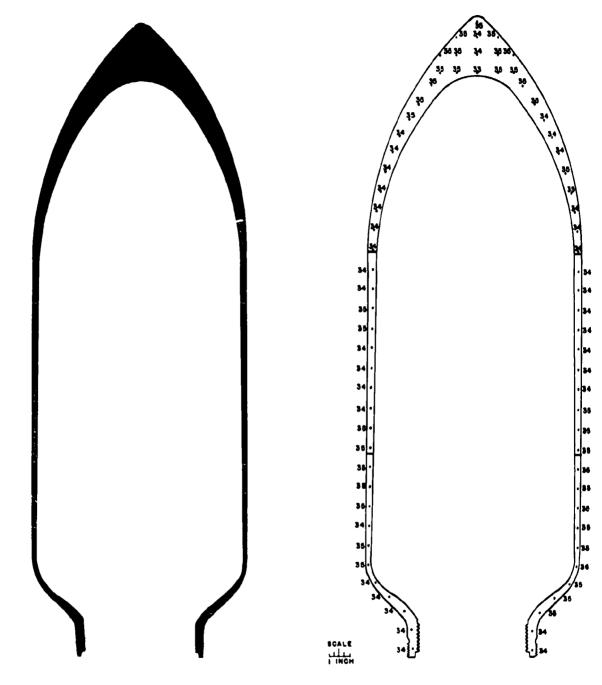
PHD-55557 FIGURE 9 March 1959

SAMPLE WARHEAD NO. 3 HARDNESS DISTRIBUTION AND MACROSECTION OF BULLPUP WARHEAD EX 29 MOD O AISI 4340 Hardness Values: Rockwell C Scale Etch: 50% Hydrochloric Acid

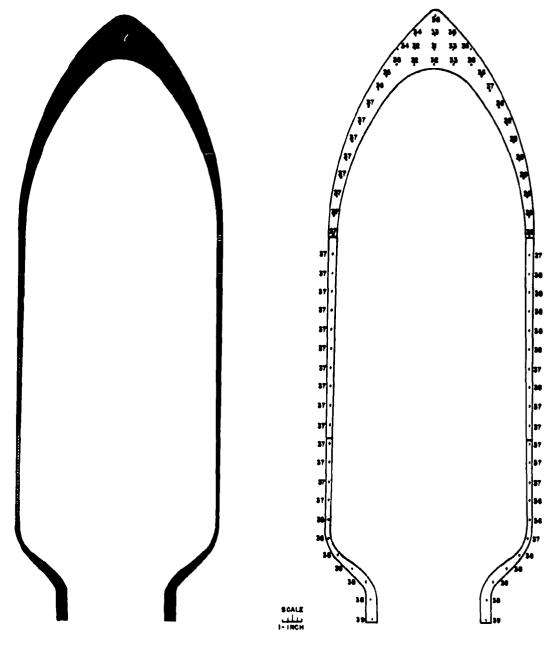
PHD-55558 FIGURE 10 April 1959

SAMPLE WARHEAD NO. 4
HARDNESS DISTRIBUTION AND MACROSECTION OF BULLPUP WARHEAD
EX 29 MOD 1 AISI 4140
Hardness Values: Rockwell C Scale
Etch: 50% Hydrochloric Acid

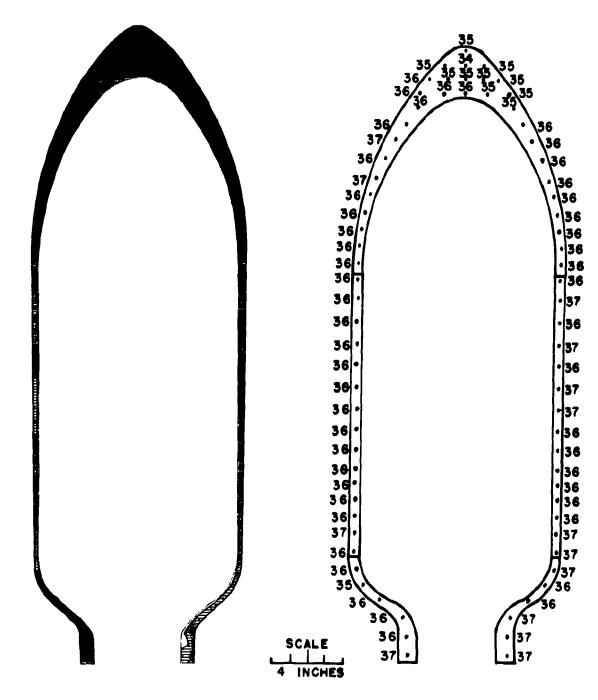
FIGURE 11

SAMPLE WARHEAD NO. 5 HARDNESS DISTRIBUTION AND HACROSECTION OF BULLPUP HARHEAD EX 29 MOD 3 AISI 4340 Hardness Values: Rockwell C Scale Etch: 50% Hydrochloric Acid

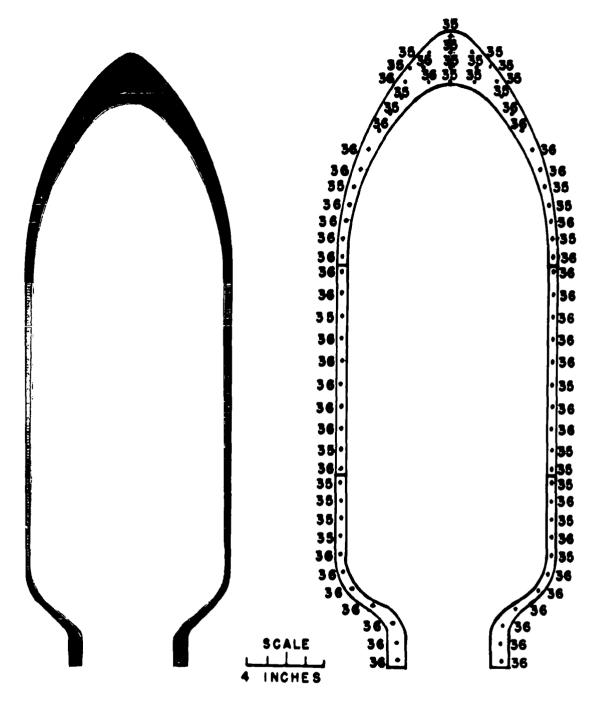
PHD-55560 FIGURE 12 June 1959

SAMPLE WARHEAD NO. 6
HARDNESS DISTRIBUTION AND MACROSECTION OF BULLPUP WARHEAD
EX 29 MOD 3 AISI 4340
Hardness Values: Rockwell C Scale

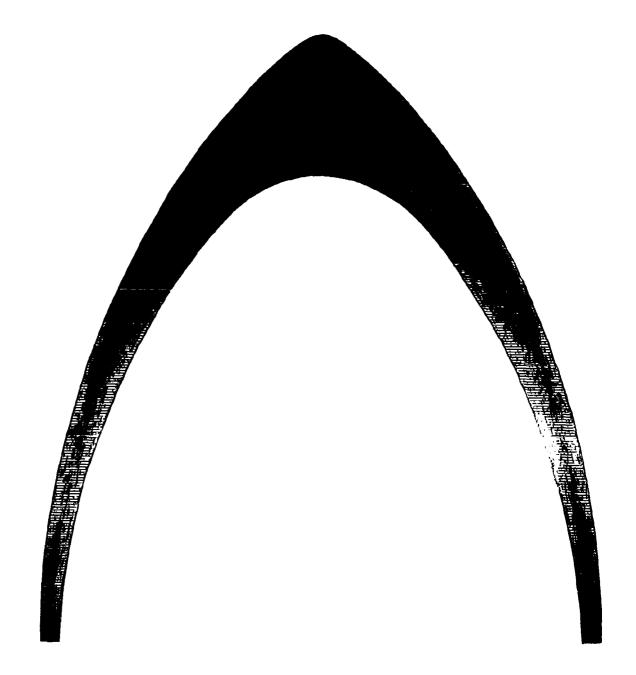
PHD-55561 FIGURE 13 December 1958

SAMPLE WARHEAD NO. 1
MACROSECTION OF COIVE FROM BULLPUP WARHEAD EX 29 MOD 1 AISI 4140
Etch: 50% Pydrochloric Acid

g. Macro-etch Test - Figures 13 through 19 show a large view of the ogive sections of the warhead bodies after macro-etching. The flow lines in the AISI 4140 bodies (Figures 13, 15 and 17) are more prominent than in the AISI 4340 bodies (Figures 14, 16, 18 and 19). Warhead body No. 2 as shown in Figure 14 represents the first lot of AISI 4340 warhead bodies to be received. The pitted condition in the heavy nose section just forward of the cavity is evidence of faulty forging practice. A study indicated that too rapid extrusion of the material at the forward end of the coining punch caused the material to leave the punch and resulted in the voided condition.

Slight changes to forging tools and rearrangement of forging passes successfully eliminated this pitted condition in later bodies No. 3, 5 and 6 shown in Figures 16, 18 and 19. Except for the pitted condition in body No. 2, Figure 14, the results of macro-etch test (Figures 13 through 19) show all warhead bodies to be of satisfactory quality.

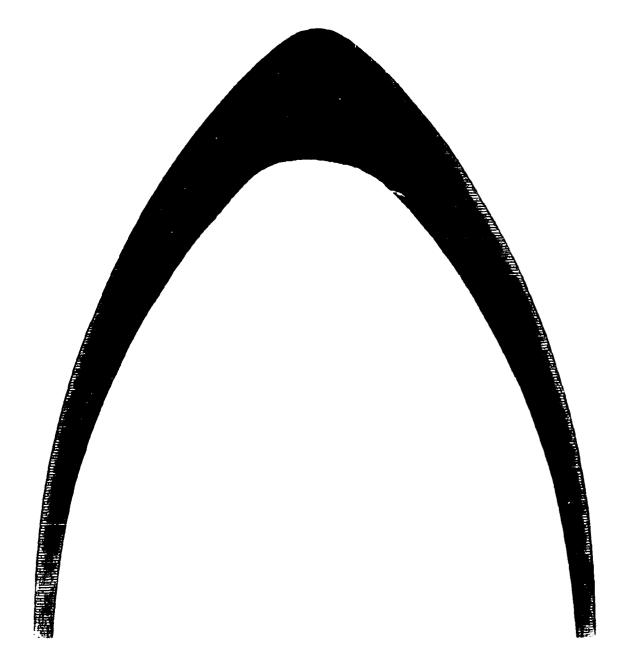
PHD-55562 FIGURE 14 January 1959

SAMPLE WARHEAD NO. 2
MACROSECTION OF CGIVE FROM BULLPUP WARHEAD EX 29 MOD 0 AISI 4340
Etch: 50% Hydrochloric Acid

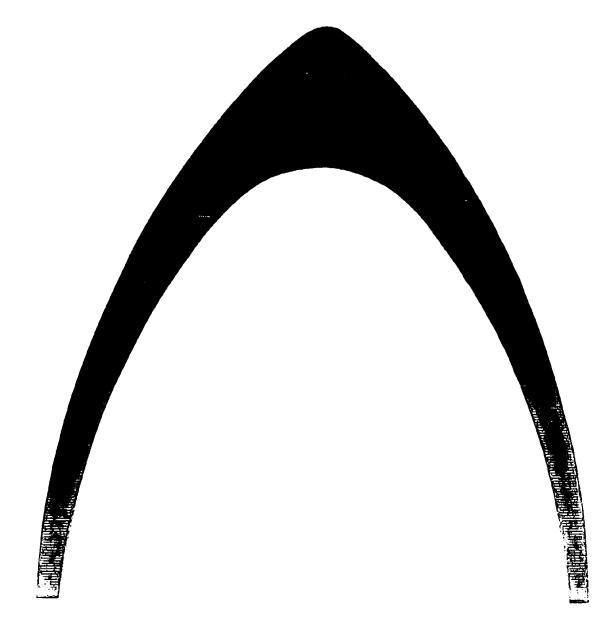
FIGURE 15

SAMPLE WARHEAD NO. la PACROSECTION OF OGIVE FROM BULLPUP WARHEAD EX 29 NOD 1 AISI 4140 REHEAT-TREATED Etch: 50% Hydrochloric Acid

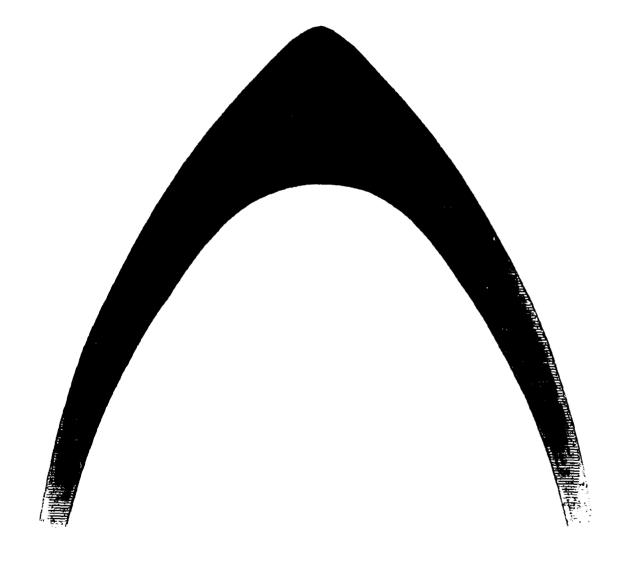
FIGURE 16

SAMPLE WARHEAD NO. 3
MACROSECTION OF OGIVE FROM BULLPUP WARHEAD EX 29 MOD 0 AISI 4340
Etch: 50% Hydrochloric Acid

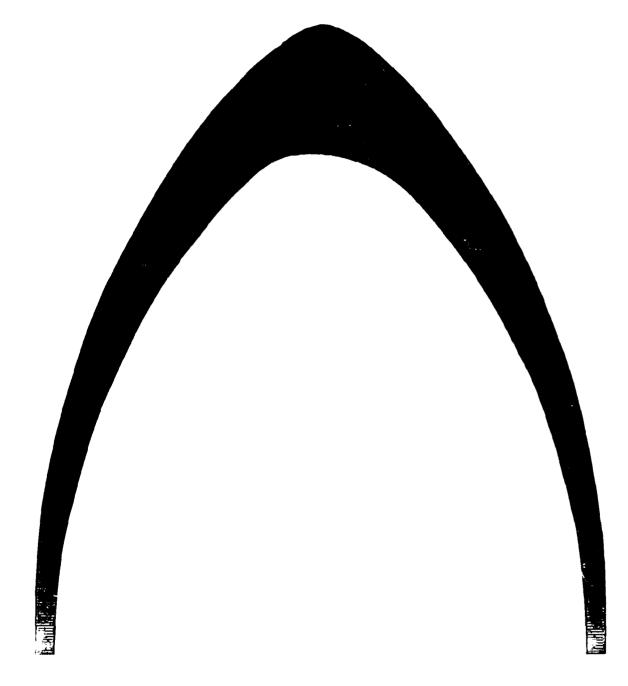
PHD-55565 FIGURE 17 April 1959

SAMPLE WARHEAD NO. 4
MACROSECTION OF OGIVE FROM BULLPUP WARHEAD EX 29 MOD 1 AISI 4140
Etch: 50% Hydrochloric Acid

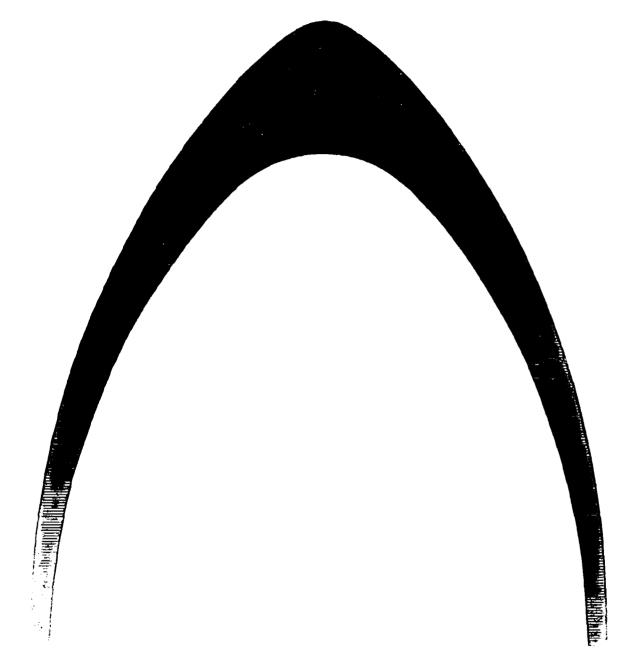
PHD-55566 FIGURE 18 June 1959

SAMPLE WARHEAD NO. 5 MACROSECTION OF OGIVE FROM BULLPUP WARHEAD EX 29 MOD 3 AISI 4340 Etch: 50% Hydrochloric Acid

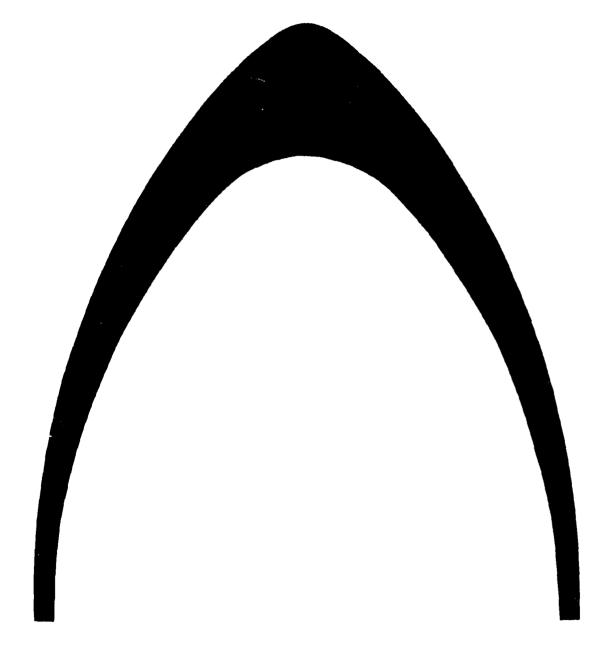
PHD-55567 FIGURE 19 June 1959

SAMPLE WARHEAD NO. 6
HACROSECTION OF CGIVE FROM BULLPUP WARHEAD EX 29 MOD 3 AISI 4340
Etch: 50% Hydrochloric Acid

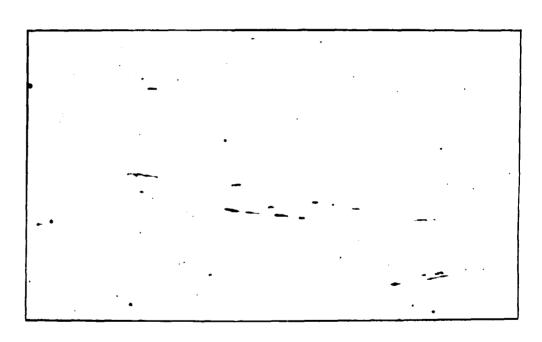
FIGURE 27

Sample Warhead No. 1

PHOTOMICROGRAPHS OF BULLPUP WARHEAD EX 29 MOD 1 AISI 4140

Location A and D in Figure 5

- i. <u>Inclusions</u> The inclusions in the warhead bodies at locations A and D of Figure 5 are shown in Figures 27 through 33. The drawn out nature of the inclusions at location D gives an indication of the degree and direction of the forging and drawing of the steel at this location. The ASTM standard rating of the inclusions in the warhead bodies (Figures 27 through 33) is less than three and indicates satisfactory material.

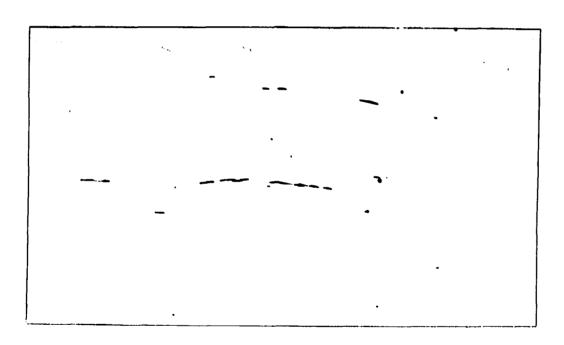
FIGURE 28

Sample Warhead No. 2

PHOTOLICROGRAPHS OF BULLPUP WARHEAD EX 29 HOD C AISI 4340

Locations A and D in Figure 5

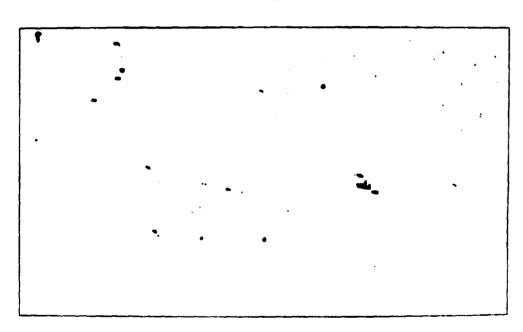
FIGURE 29

Sample Warhead No. la

PHOTOMICROGRAPHS OF BULLPUP WARHEAD EX 29 MOD 1 AISI 4140 REHEAT TREATED

Locations A and D in Figure 5

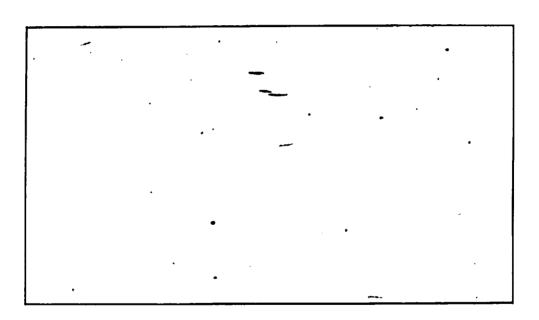
FIGURE 30

Sample Warhead No. 3

PHOTOMICROGRAPHS OF BULLPUP WARHEAD EX 29 MOD 0 AISI 4340

Location A and D in Figure 5

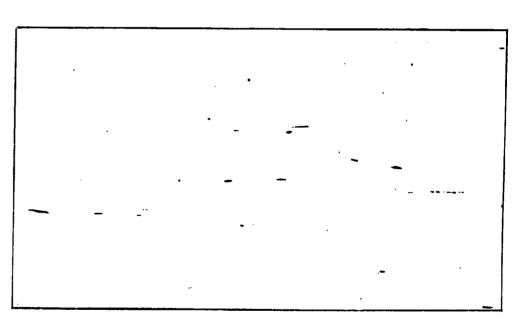
FIGURE 31

Sample Warhead No. 4

PHOTOMICROGRAPHS OF BULLPUP WARHEAD EX 29 MOD 1 AISI 4140

Location A and D in Figure 5

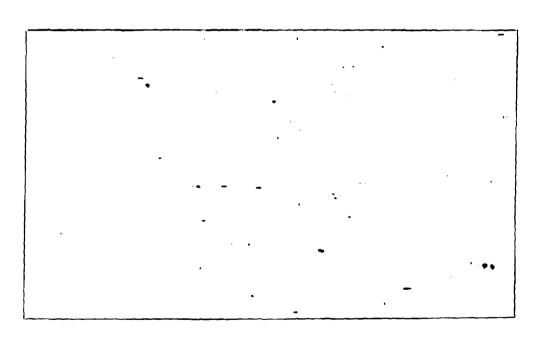
FIGURE 32

Sample Warhead No. 5

PHOTO ICROGRAPHS OF BULLPUP WARHEAD IN 29 MOD 3 AISI 4340

Location A and D in Figure 5

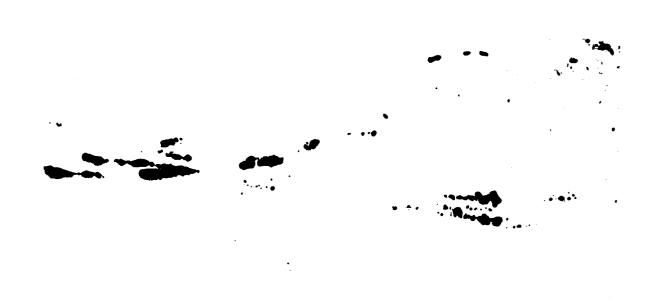
(A) Marhead Serial No. 139A From Lot 103

(E) Marhead Serial No. 103A From Lot 102

The results of a metallographic examination of inclusions in two warhead bodies representing different production lots of EX 29 Mod 3 warheads are illustrated in Figure 41. Both warhead bodies were processed from the same heat of steel and had chemical compositions within the range shown in Table 1(B) for the AISI 4340 warhead bodies. The manufacturer reported the mechanical properties of both bodies to be in accordance with the requirements of Table 1(A). The warhead body with inclusions as shown in Figure 41(A) passed the required ballistic penetration test while the warhead body with inclusions as shown in Figure 41(B) failed the ballistic penetration test by circumferential rupture near the base end of the cylindrical section. In comparison with the inclusions in development quality bodies in Figures 27 through 33 the inclusions in the body which passed ballistic test (Figure 41(A)) are somewhat heavier, whereas the inclusions in the body which failed the ballistic test Figure 41(B) are considerably heavier.

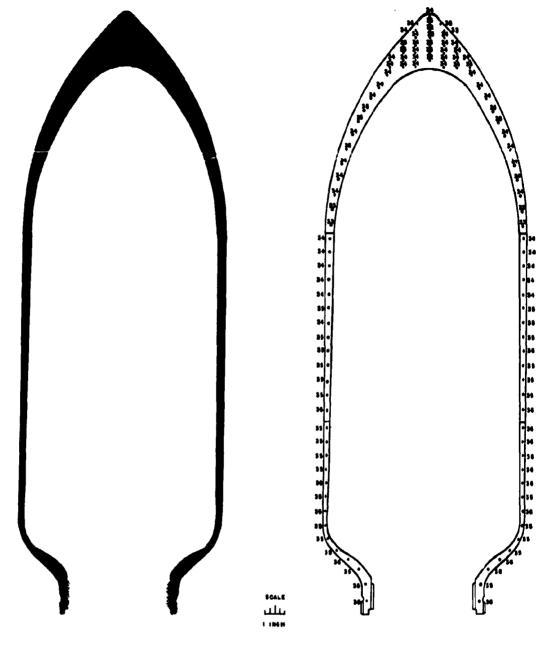
FIGURE 44

PILOT LOT, SAMPLE WARHEAD, SERIAL NO. 4
HARDNESS DISTRIBUTION AND MACROSECTION OF BULLPUP WARHEAD
EX 29 MOD 3 AISI 4340

Hardness Values: Rockwell C Scale Etch: 50% Hydrochloric Acid

tensile, Charpy V-notch impact, macroscopic examination, and microscopic examination for structure, inclusions, banding and grain size. The hardness distribution representative of this pilot lot warhead body shown in Figure 44 ranges from 32 to 36 Rockwell C with the low hardnesses obtained mainly in the ogive section. The tensile properties met the requirements of Table 1(A). The Charpy V-notch impact strength was 34.5 to 38.5 ft-lbs at 0°C and the transition temperature was -40°C. Such impact properties are lower than the 40 ft-lb minimum strength specified in Table 1(A) and significantly inferior compared with the impact properties listed in Table 1(C) for AISI 4340 development quality warhead bodies. The macroetch section in Figure 45 shows heavier flow lines than any of the test sections from development quality warhead bodies shown in Figures 13 through 19. The microstructure in Figure 46 is as uniform as the microstructure of the better AISI 4340 warhead bodies No. 2 and 6 (Figures 21 and 26) indicating satisfactory heat treating practice. The inclusions in Figure 47 are mainly sulfides and are more abundant than the inclusions in development quality bodies in Figures 27 through 33. The banding in Figure 48 is considered normal. The grain size was 8-9 (ASTM No.).

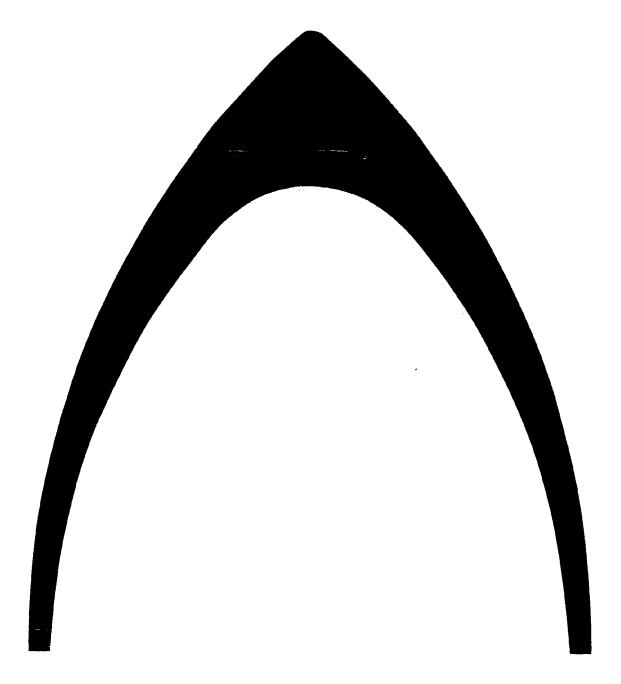
FIGURE 45

PILOT LOT SAMPLE WARHEAD, SERIAL NO. 4 MACROSECTION OF OGIVE FROM BULLPUP WARHEAD EX 29 MOD 3-AISI 4340

Etch: 50% Hydrochloric Acid
